STRUCTURES NOTE 461

**STRUCTURAL DESIGN OF BFRP PATCHES FOR
MIRAGE WING REPAIR**

R. JONES and R. J. CALLINAN

JULY 1980

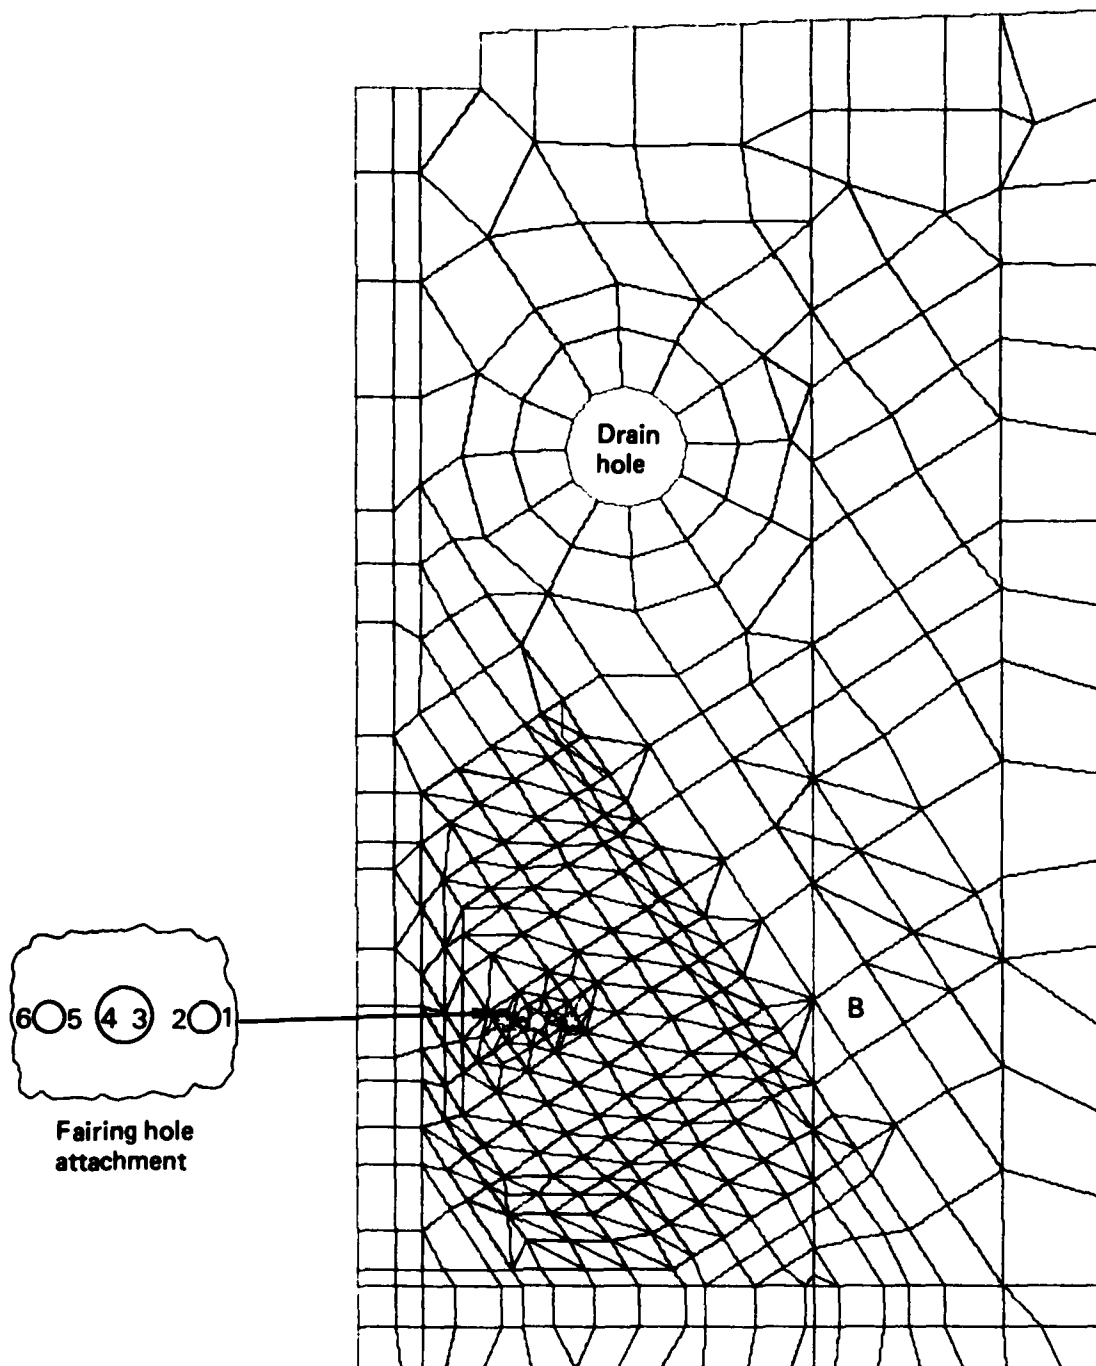
FIG. 1 FINITE ELEMENT MODEL OF FAIRING HOLE REGION

Shortly after the BFRP patch for the fairing attachment hole had been designed cracks were found, in service aircraft, in the drain hole region slightly inboard of the fairing attachment hole (see Fig. 1). ARL was again tasked with the development of a BFRP patch for this area. After consultation with the RAAF it was decided that the patch be developed for installation in the field. Because of the significance of the cracking and the long life required of the repair a considerable amount of research was required before the repair could be implemented.

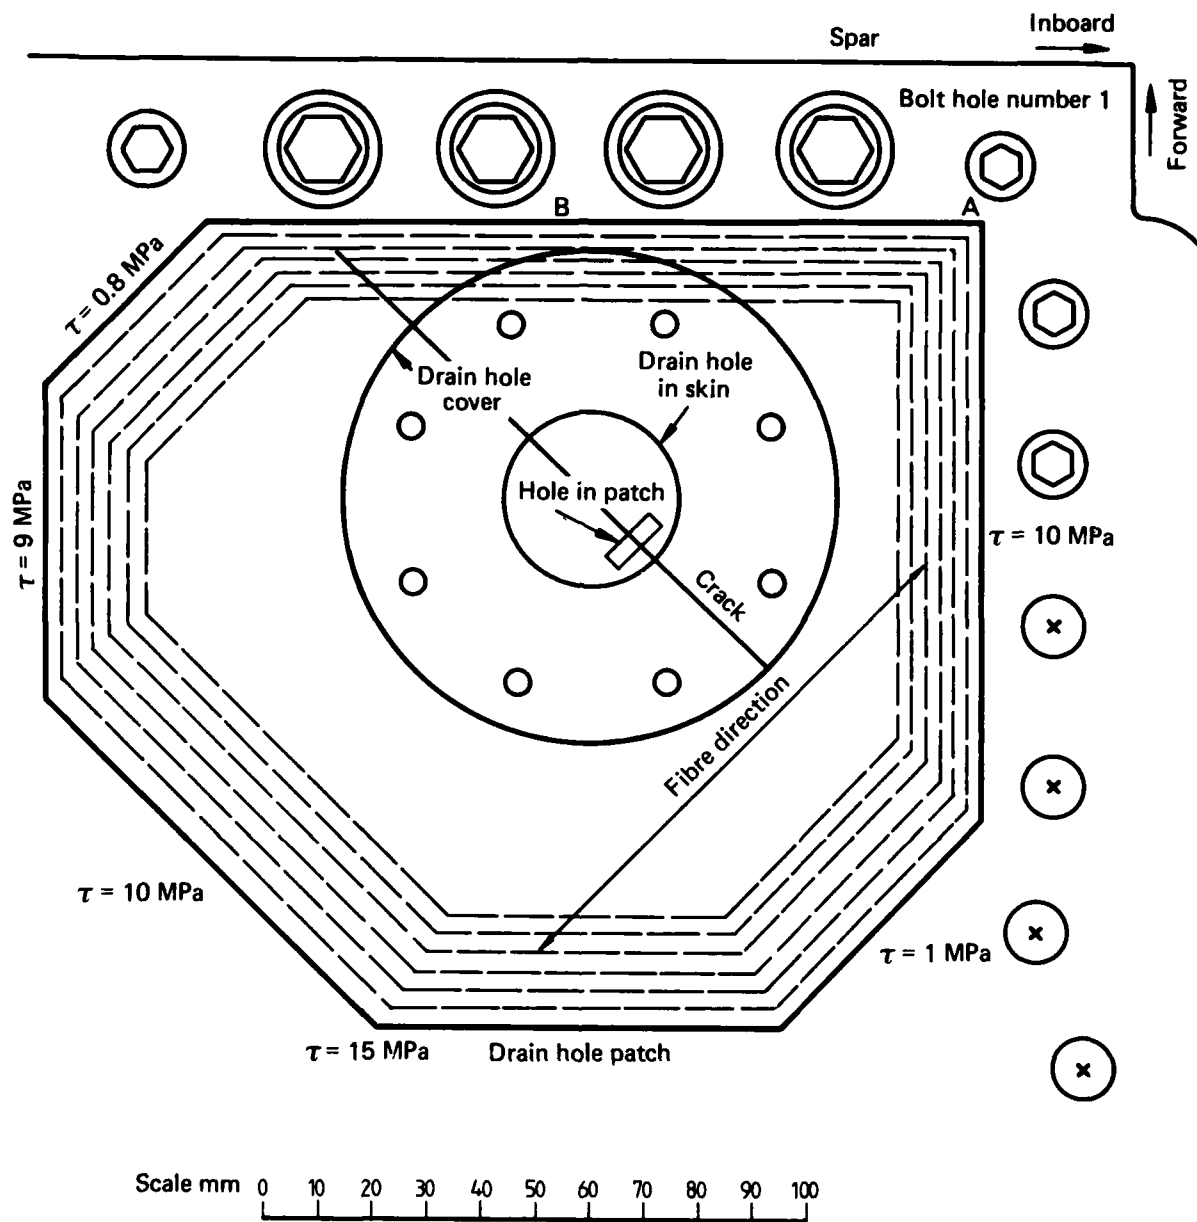
FIG. 4 GENERAL ARRANGMENT OF PATCHES FOR DRAIN HOLE

For each of the patches the maximum shear stresses in the adhesive bonding the patch to the wing skin occurred at points A, B, C and D (see Fig. 4). The maximum stresses in the fibres occurred at point D for the patches with a hole in the patch, and in the fibres over the hole in the patches with the hole partially covered. The values for these stresses, along with the percentage reduction of the stress intensity factor k_1 at each tip, achieved by each patch are shown in Table 4. Here k_{1u} and k_{1p} are the values of the stress intensity factors before and after patching respectively.

Having thus obtained a reasonable model for the unpatched crack we add to this a finite element representation of the repair. Six BFRP patch configurations were considered, each with the same plan form, see Figure 4. Each patch was modelled using approximately 380 of the "bonded" elements previously described.

All of the six patches considered are unidirectional laminates and are internally stepped, i.e., with the longest ply on the outside. The fibre direction is at ninety degrees to the crack.

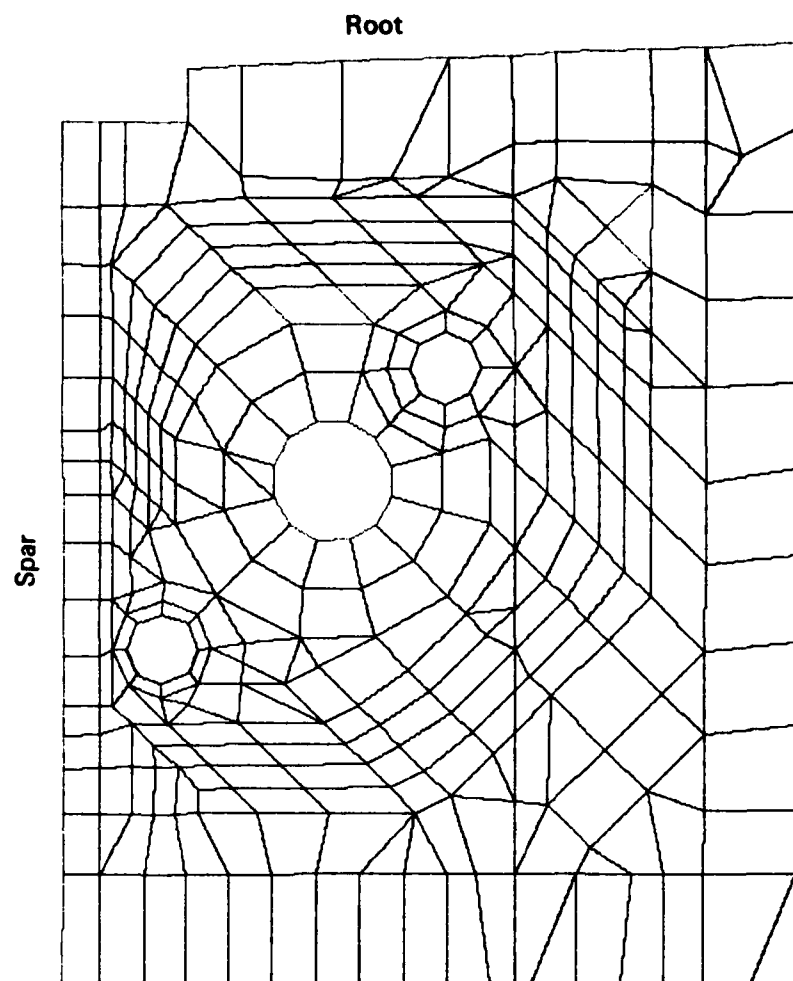
FIG. 5 FINITE ELEMENT MESH FOR THE DRAIN HOLE REGION

As a first step in the design of the repair a study of the cracked, but unpatched, region was undertaken. A detailed finite element model of the area surrounding the drain hole region was developed, see Figure 5. This contained the crack, described above, and which used the special crack tip elements developed by the authors in References [8, 9]. The loads applied to this model were obtained directly from the stress distribution which resulted from the finite element model described in Section 3 and which correspond to the 7.5 g load case.

This study gave the values of the stress intensity factors to be $k_1 = 72 \text{ MPa}\sqrt{m}$ and $k_2 = 3.3 \text{ MPa}\sqrt{m}$ at the tip closest the spar and $k_1 = 68 \text{ MPa}\sqrt{m}$, $k_2 = 0.5 \text{ MPa}\sqrt{m}$ at the tip closest to the root rib. These values are consistent with a fractographic examination of the crack which showed that the crack was essentially growing as a mode I fracture and that of the two crack tips the tip closest to the spar was growing the fastest. Indeed the tip closest to the spar was found to be very close to final failure.

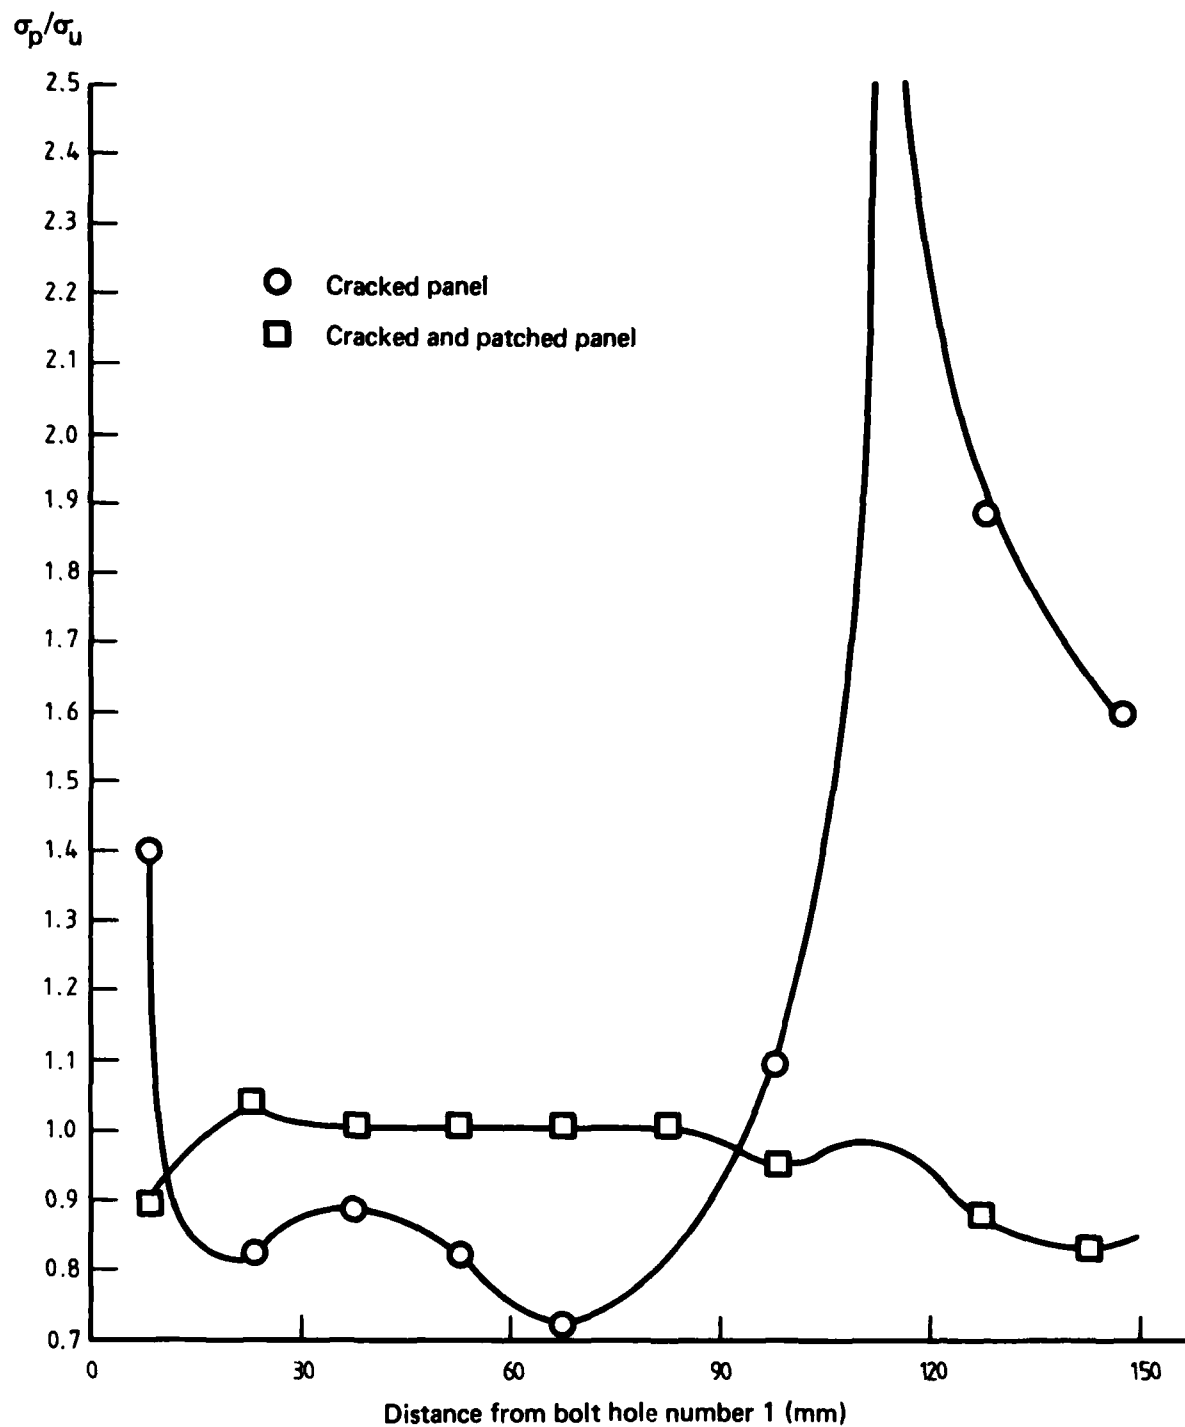
FIG. 6 EFFECT OF PATCH OF SKIN STRESSES

Let us now examine patch 6 in more detail paying particular attention to the effect it has on the spar. In Figure 6 is shown the ratio of the maximum principal stress σ_p in the skin panel, along the line of attachment to the spar, for the case when the panel is either cracked and patched or cracked and unpatched, to the maximum principal stress σ_u at corresponding locations in the uncracked panel. From this figure we see that the patch removes the peaks in the stress distribution in the skin in the vicinity of the spar. Indeed the stress distribution in the patched panel is very similar to that in the uncracked panel.
